**SEPTIC SYSTEM □
SANITARY SURVEY □
for □
Santa Barbara County □
California □**

**Prepared For:
Santa Barbara County
Environmental Health Services**

March 2003

Questa Engineering Corporation
1220 Brickyard Cove Road, Suite 206
Point Richmond, California 94807
(510) 236-6114

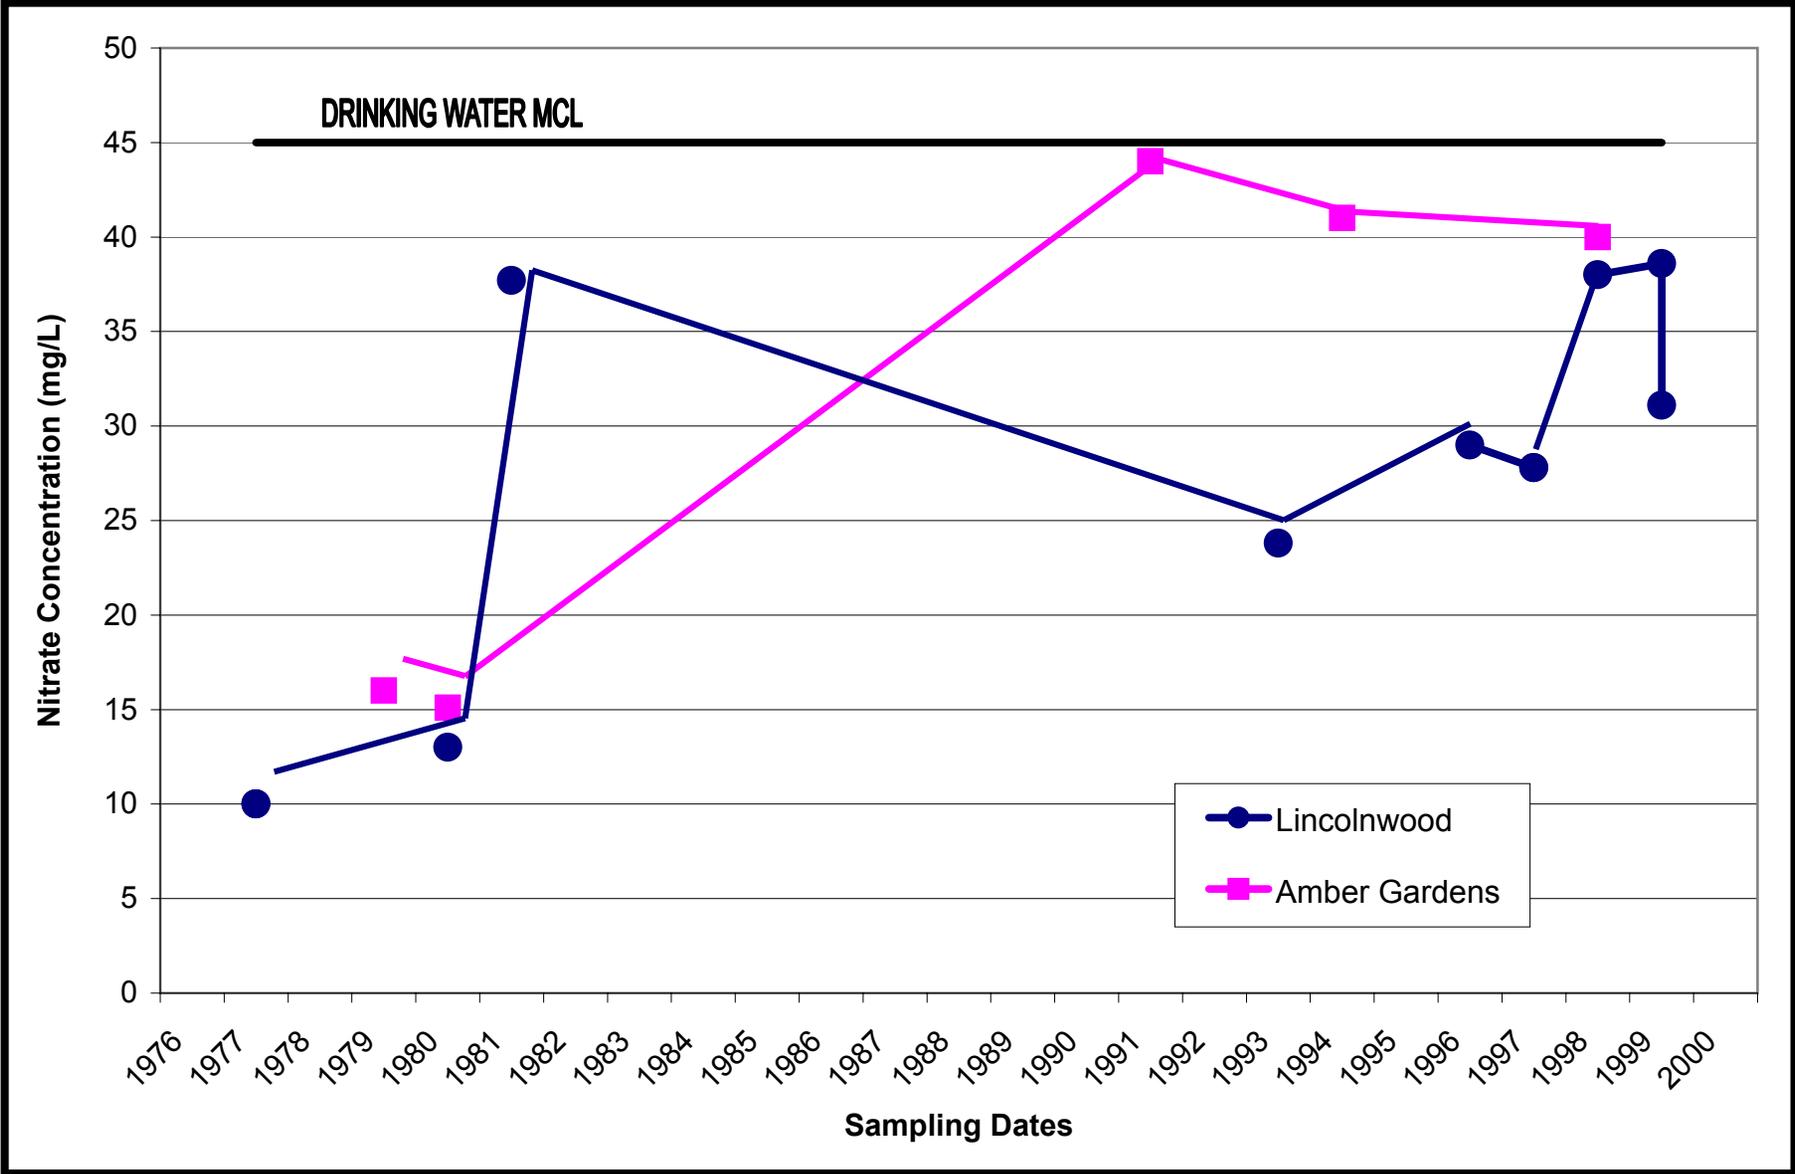
FIGURE 7-3

2. **Sunset Road/Carol Avenue Area.** Nitrate data for the Amber Gardens and Lincolnwood Subdivision water wells in the Sunset Road/Carol Avenue area of Santa Barbara show an increasing trend in nitrate concentration over the past 20 years, as displayed graphically in **Figure 7-3**. A map showing the location of these wells in relation to the septic systems in the Sunset Road/Carol Avenue area is provided in **Figure 7-4**. Also shown are the approximate groundwater flow directions in the area. As can be seen, the Amber Gardens well lies downgradient of the main concentration of septic systems in this area, which is otherwise primarily an urbanized sewered area. The Lincolnwood well lies approximately at the groundwater divide (between the Goleta and Santa Barbara Basins) according to a 1982 U.S. Geological Survey study; and the recharge influence of septic systems is not as clear for this well. However, there may be localized drawdown effects from the well that are not reflected in the 1982 USGS study.

According to available record, many of the systems in this remaining “pocket” of septic systems utilize drywells. The water depth reported in the supply wells ranges from about 70 to 90 feet. Given the dense concentration of septic systems on relatively small lots so close by, there is a reasonable likelihood that the elevated nitrate concentrations in these wells is due mainly to septic system discharges.

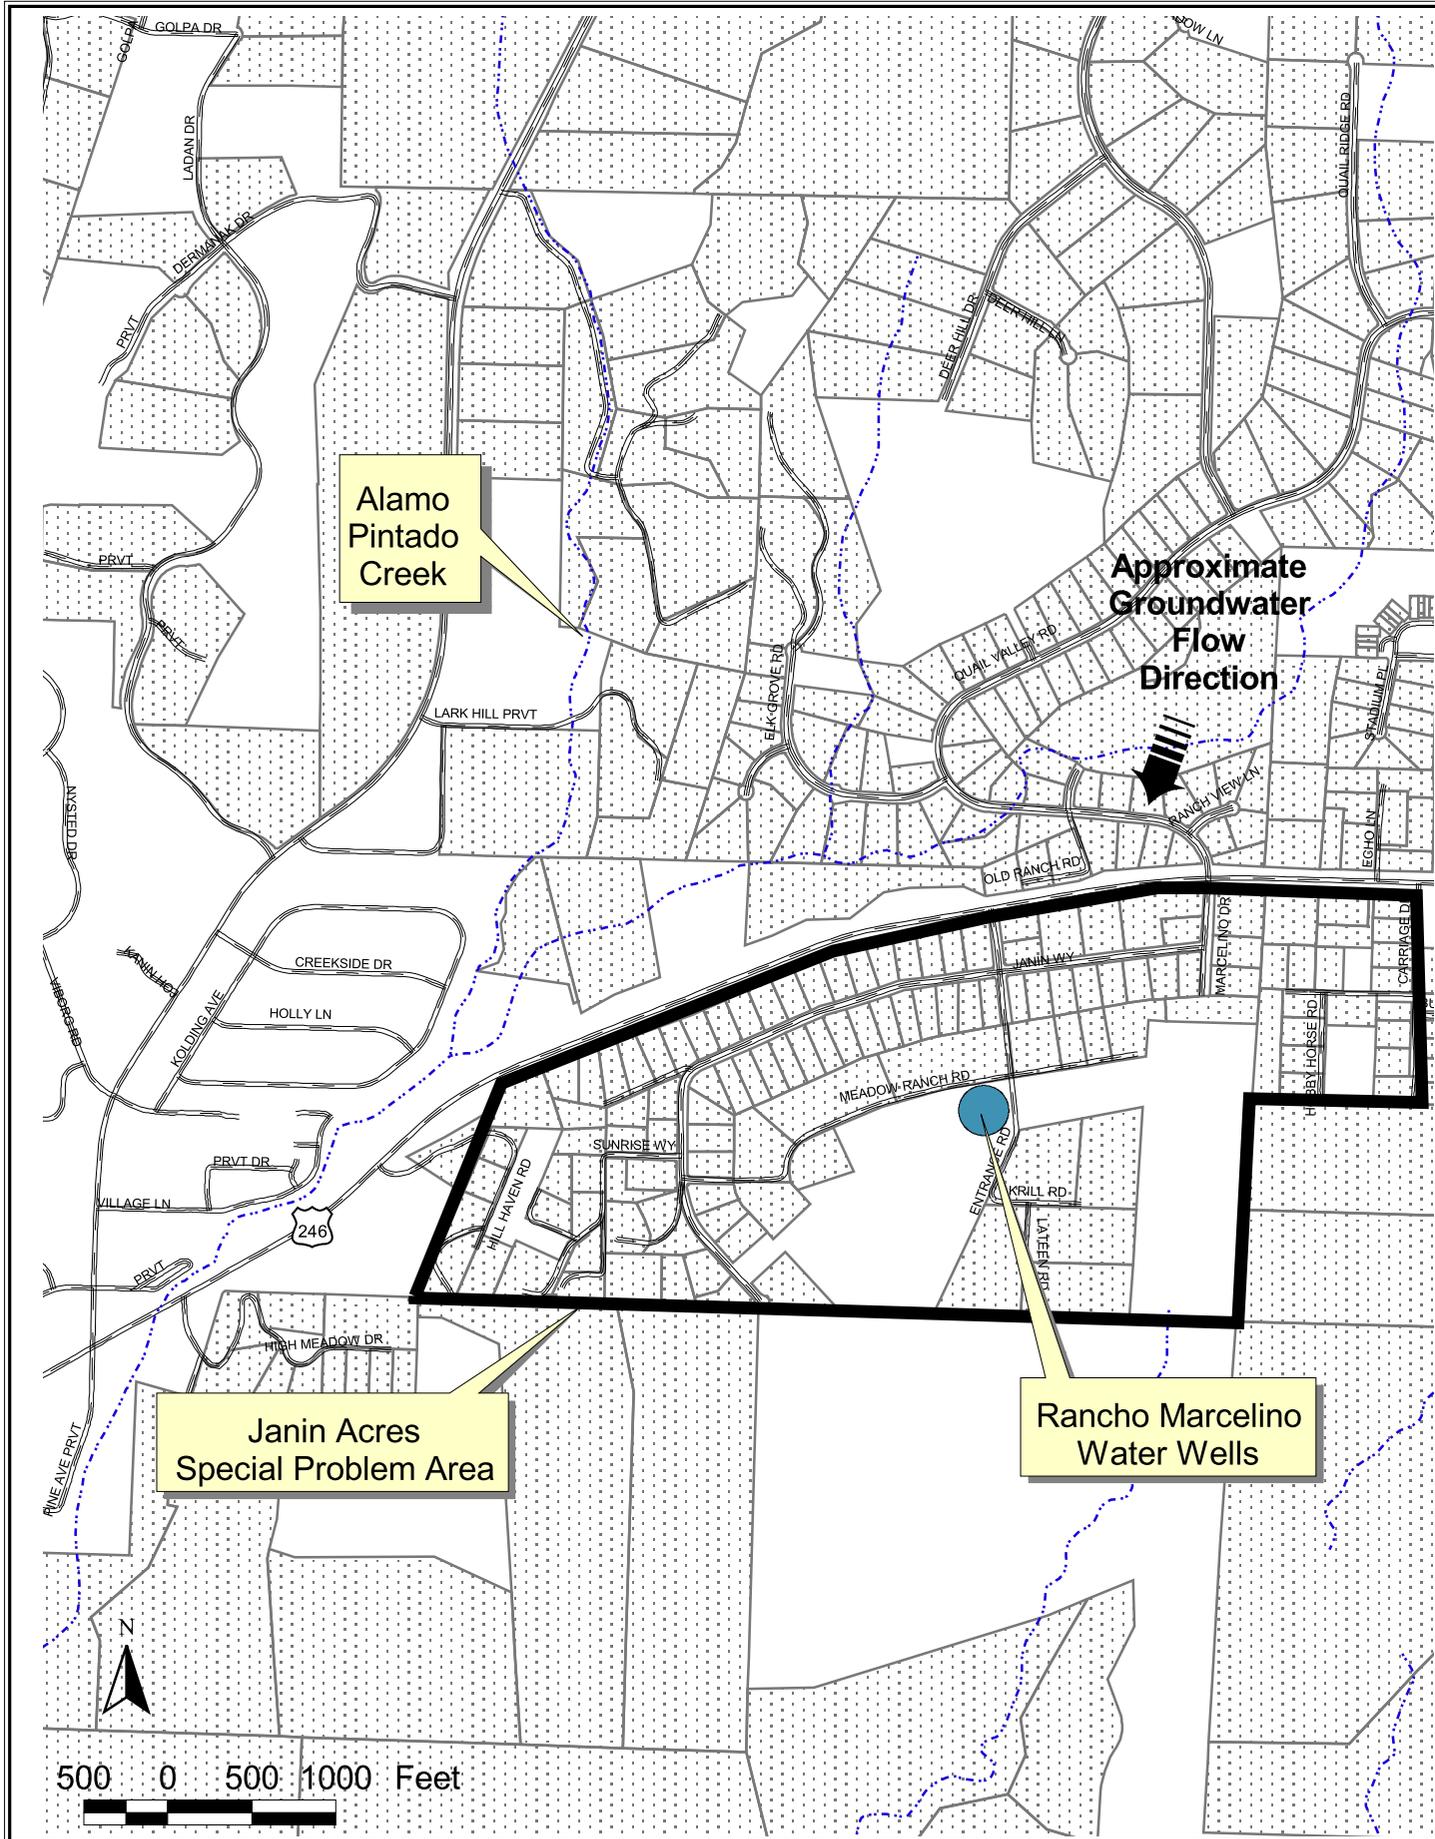
contour maps for the area indicate a general northeast to southwest flow direction in the area. Most of the parcels within the subdivision lie in areas upgradient and in close proximity to the Rancho Marcelino water wells. A number of unsewered parcels near Santa Ynez also lie in upgradient areas that potentially contribute to recharge of the Rancho Marcelino wells; these parcels (and their associated septic systems) are more distant from the wells than those in the immediate Janin Acres area. A map of the area showing the proximity of the septic systems to the water supply wells and the general direction of groundwater flow is provided in **Figure 7-6**.

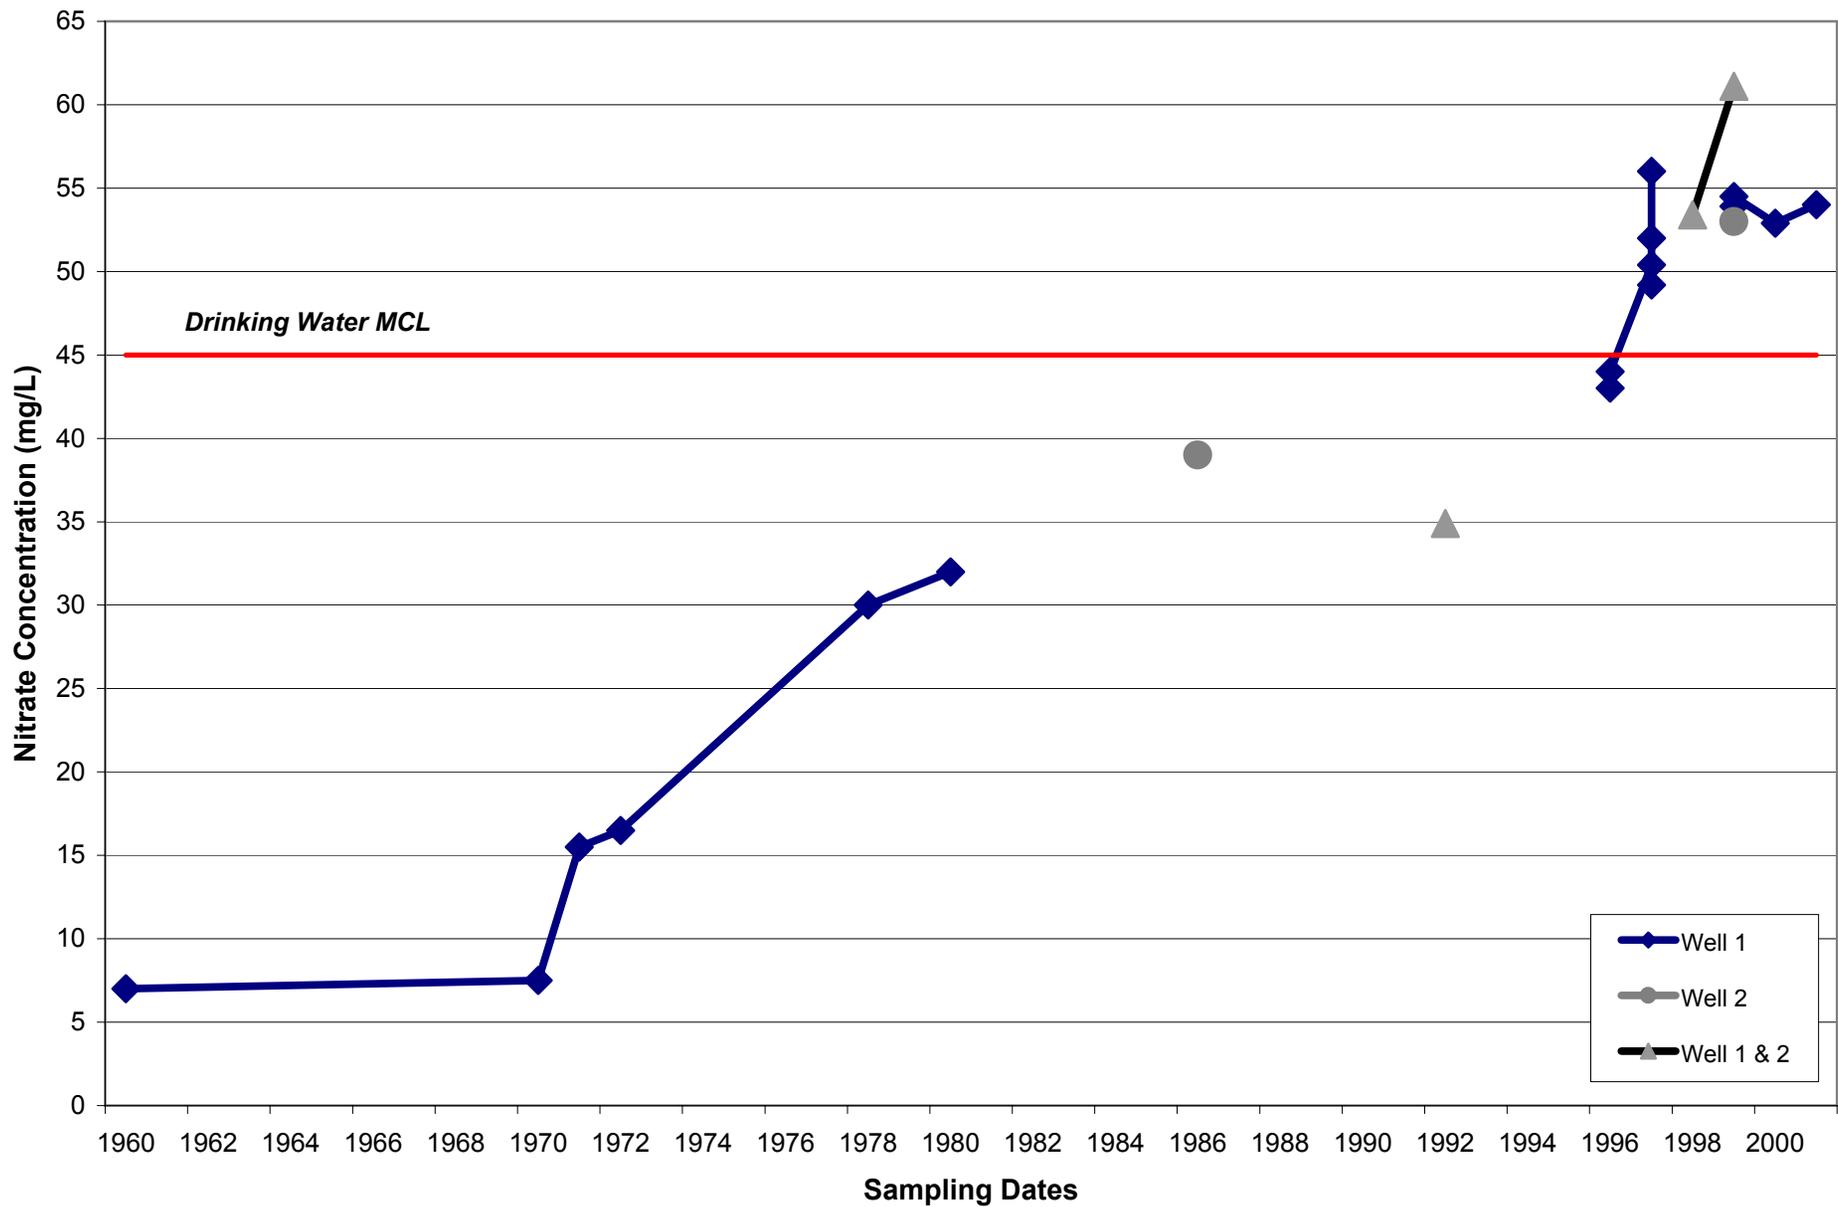
Figure 7-7
Groundwater Nitrate Concentration (as NO₃)
Janin Acres Water Supply Wells

The Janin Acres subdivision, located between Solvang and Santa Ynez, was developed in the late 1960s. The subdivision consists of 77 residences, three churches and a motel on approximately 94 acres. The water supply is obtained from two local wells, owned and operated by the Rancho Marcelino Water Company, that draw water from a depth of about 50+ feet. Nearly 80 percent of the properties in the subdivision utilize drywells for wastewater disposal. Soils testing in the area indicate that there are lenses of very coarse permeable soils at depths penetrated by or immediately below the drywells. Groundwater

Sampling of the Rancho Marcelino water wells has indicated a dramatic increase in nitrate concentration that coincides with the development of the subdivision and the use of onsite sewage disposal systems in the area. The groundwater-nitrate readings in the water supply wells from 1960 to the present are shown graphically in **Figure 7-7**. As indicated, the nitrate concentrations found in the wells has increased from less than 10 mg/l to over 50 mg/L (i.e., exceeding the drinking water MCL). The data show a strong correlation between groundwater quality degradation and the installation and use of septic systems in the Janin Acres Subdivision and neighboring areas in Santa Ynez (to the north). All septic systems contribute nitrate to the soil and groundwater environment. Deep trench and drywell disposal systems, which are used extensively in Janin Acres, are more problematic because they allow less opportunity for nitrate removal/uptake by soil and vegetation, as compared with shallow leachline designs. In this case the impact on the water wells is further exacerbated by the relatively high density of deep trench and dry well disposal system in such close proximity to the wells.
