**SEPTIC SYSTEM □
SANITARY SURVEY □
for □
Santa Barbara County □
California □**

**Prepared For:
Santa Barbara County
Environmental Health Services**

March 2003

Questa Engineering Corporation
1220 Brickyard Cove Road, Suite 206
Point Richmond, California 94807
(510) 236-6114

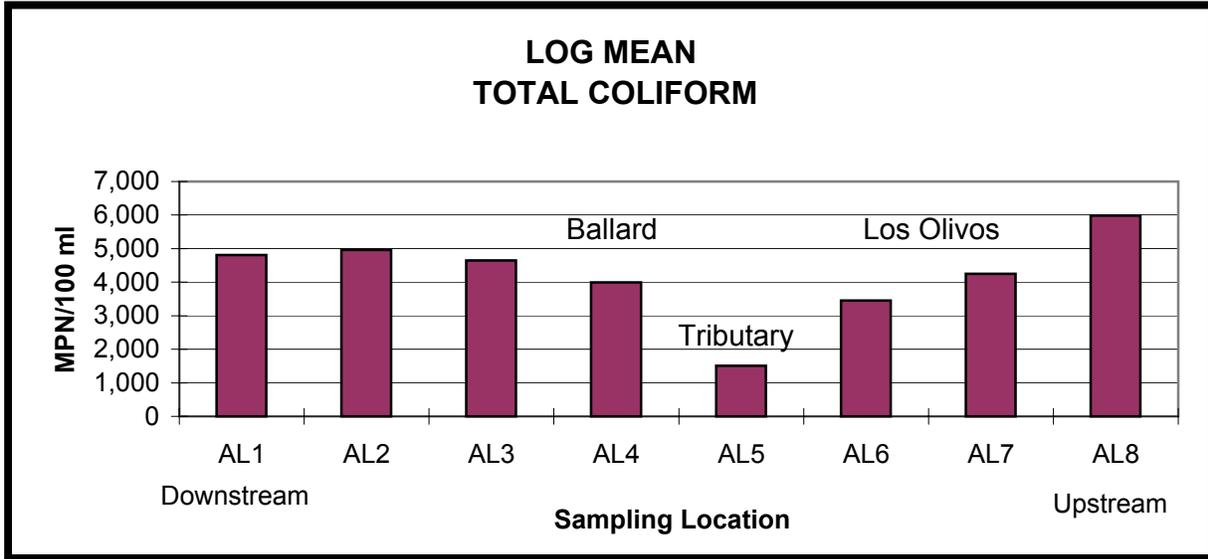
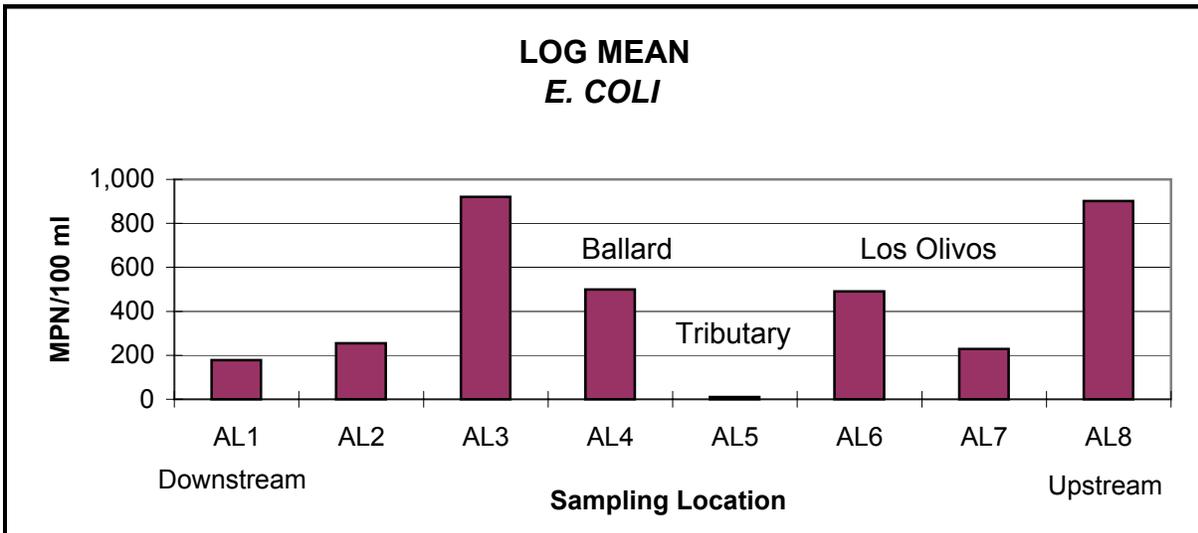
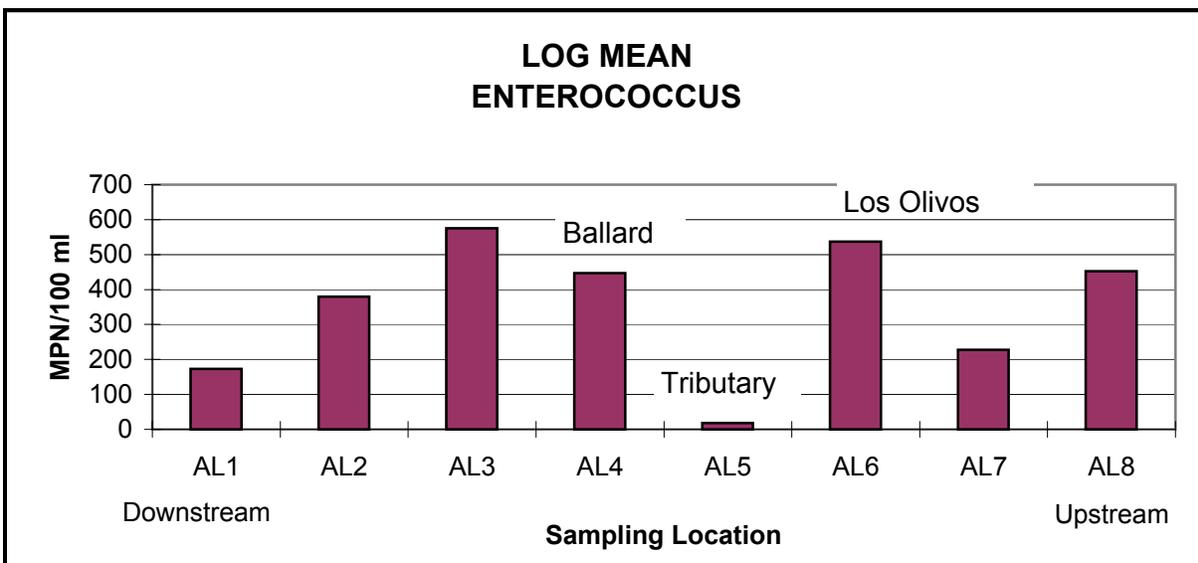
FIGURE 6-4

With respect to trends in the immediate area of Los Olivos and Ballard, both the log mean data and the single sample maximum values appear to increase in *E. coli* and Enterococcus readings between the upper and lower sampling stations adjacent to both communities. This can be seen by comparing the results for AL7 and AL6 at Los Olivos, and the results for AL4 and AL3 for Ballard (see **Figure 6-4**). There was no evidence of surface discharges to the creek during the sampling in these areas. However, given the relatively close proximity of the residences (and septic systems) to the creek, the chronic high groundwater levels, and large number of old (mostly drywell/seepage pit) systems in these communities, it is not unreasonable to expect that the bacterial readings in the creek are the result of lateral inflow from impacted groundwater beneath the two towns. Additional study including a network of groundwater monitoring wells would be needed to verify if and to what extent this is the explanation for the high bacteriological readings.

ALAMO PINTADO CREEK
Bacteriological Sample Results
